Manhole Inspection Summary

Manhole # S23K__061MH

Insp Date: **6/10/08 2:40 PM**

Location Address: **SStricker St**

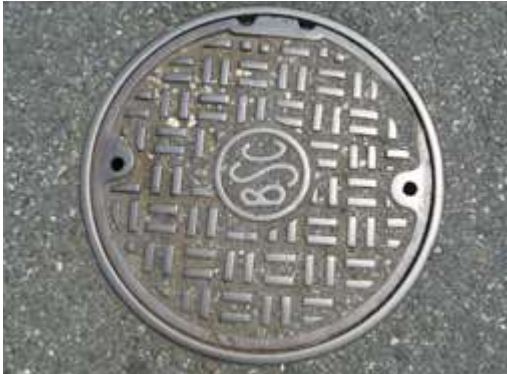
Cover View

Condition: ☐ Sound ☐ Cracked ☒ **Leaks**

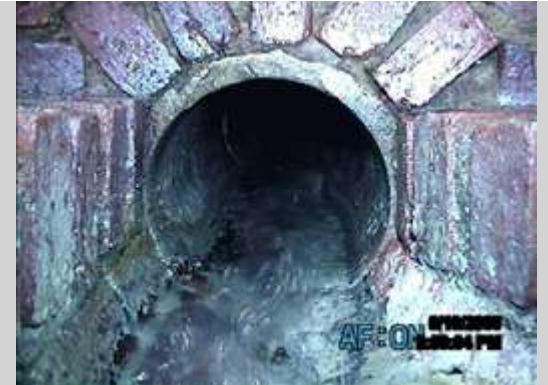
12 O'Clock Outflow

Pipe Height: **8.4** (in.) Rod and Bar (Angled)
Pipe Material: **Clay** ☐ Pipe Lined
Invert Depth: **9.73** (ft.) Flow Characteristics: **Fast**
Deposits: ☒ None ☐ Mud ☐ Sludge ☐ **Debris** ☐ Grease
Silt Depth: **0** (in.) Deposits Extent:
Infiltration: **None** Pipe Seal Cond: **Sound**

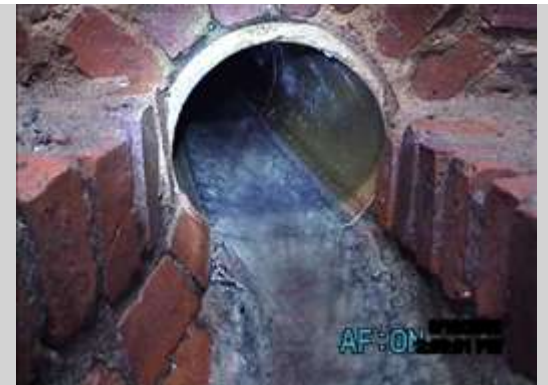
3 O'Clock Inflow

Pipe Height: **8.4** (in.) Rod and Bar (Angled)
Pipe Material: **Clay** ☐ Pipe Lined
Invert Depth: **9.64** (ft.) Flow Characteristics: **Fast**
Deposits: ☒ None ☐ Mud ☐ Sludge ☐ **Debris** ☐ Grease
Silt Depth: **0** (in.) Deposits Extent:
Infiltration: **None** Pipe Seal Cond: **Sound**
